Nothing but **HEAVY DUTY.**®

Denied Warranty On Batteries Examples

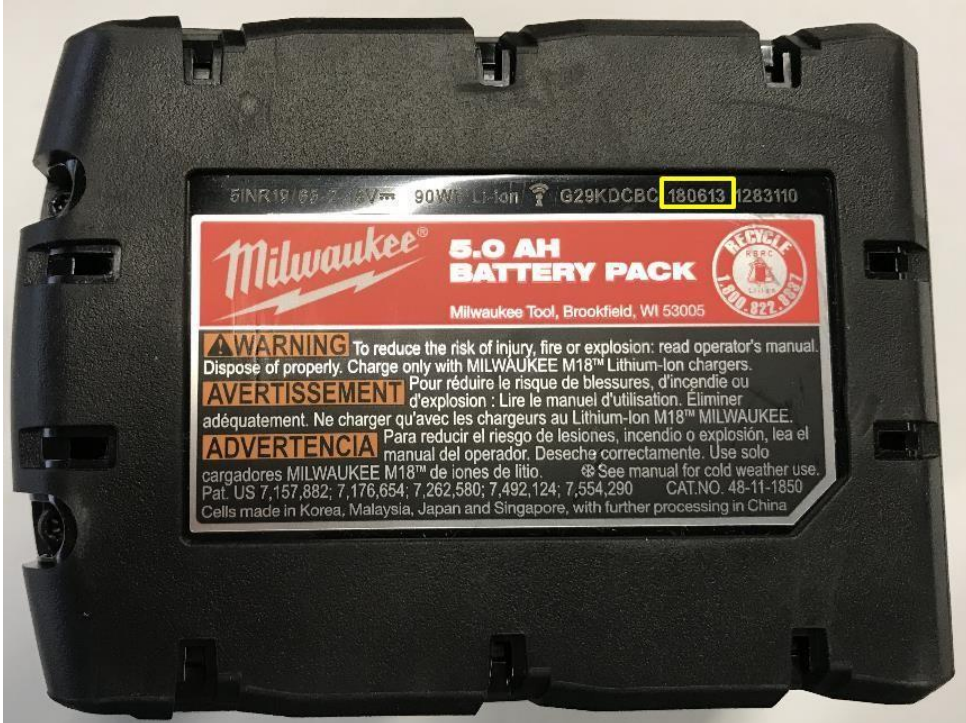
Date Code format: YYMMDD

This Date Code Reads: 180613 = 06/13/2018

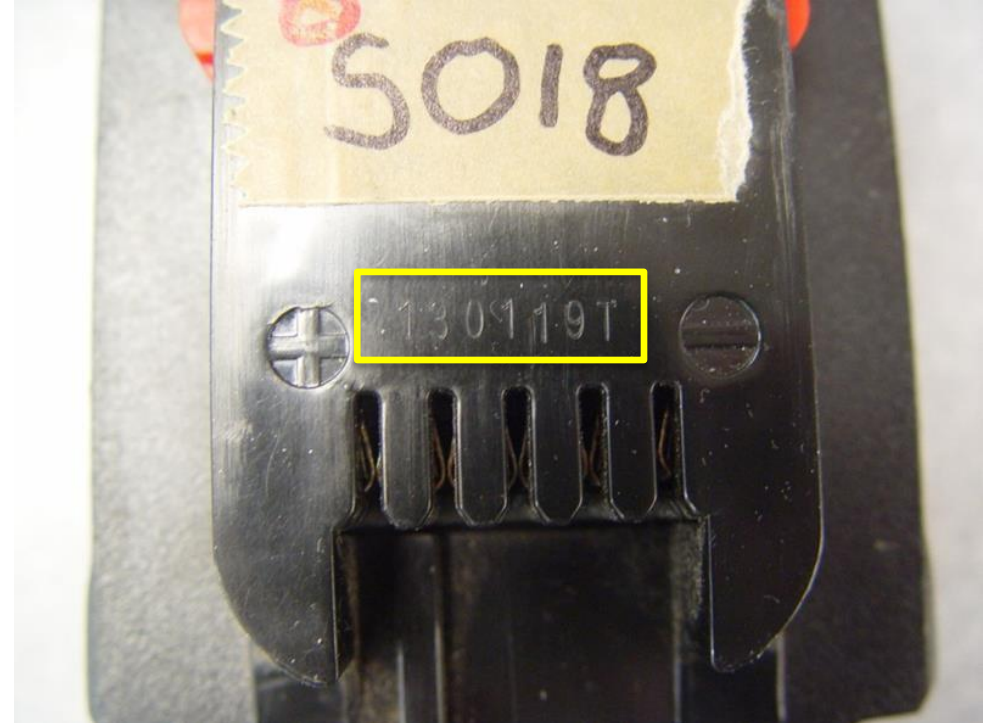
Date Code format: YYMMDD

This Date Code Reads: 130119 = 01/19/2013

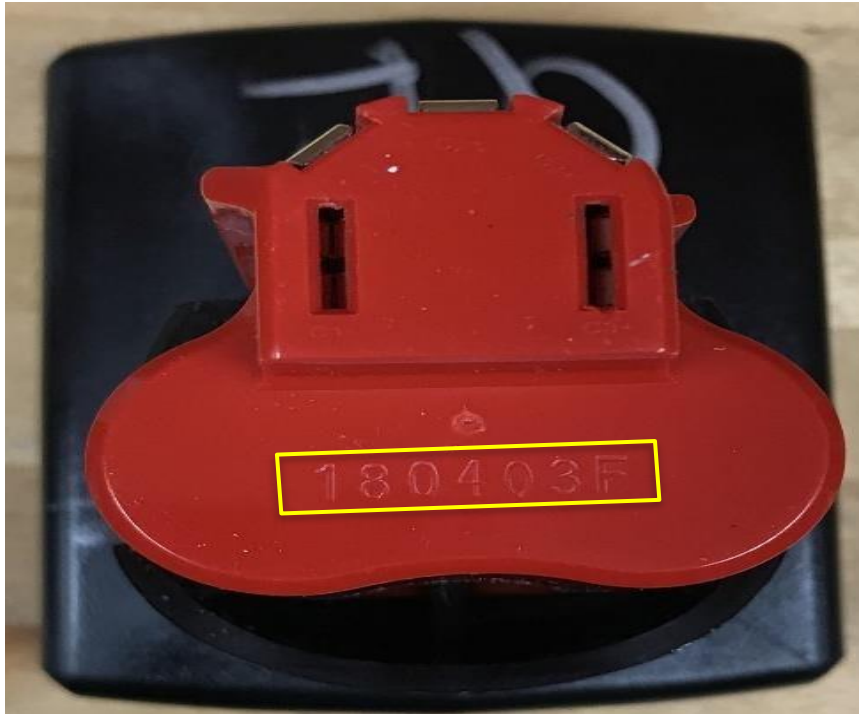
Top of Red Case Date Code Style
This Date Code Reads: 180403 Which
translates to: 04/03/2018

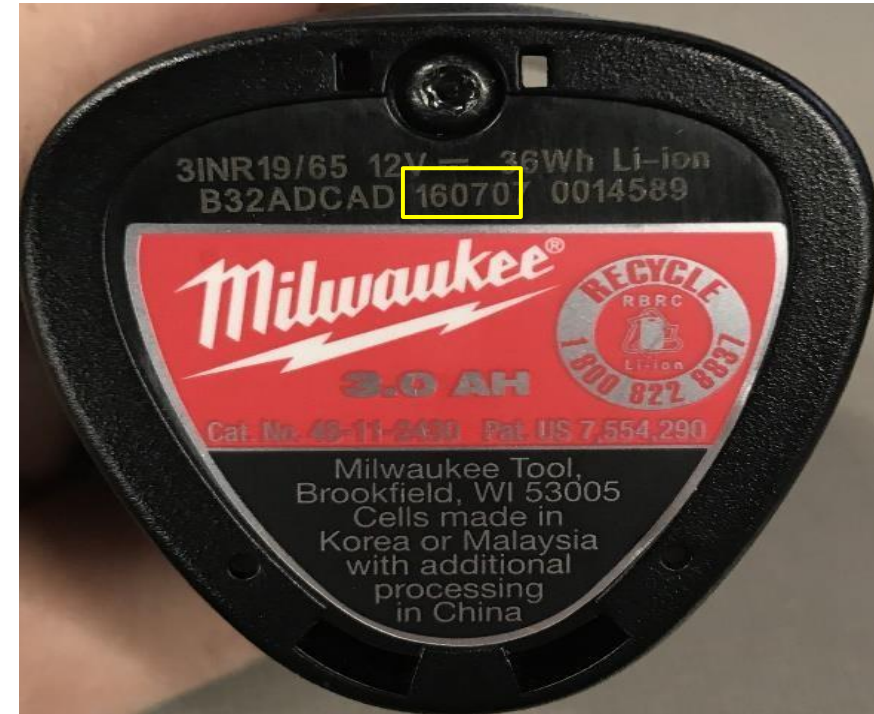
Laser Engraved Date Code Style
This Date Code Reads: 160707 Which
translates to: 07/07/2016

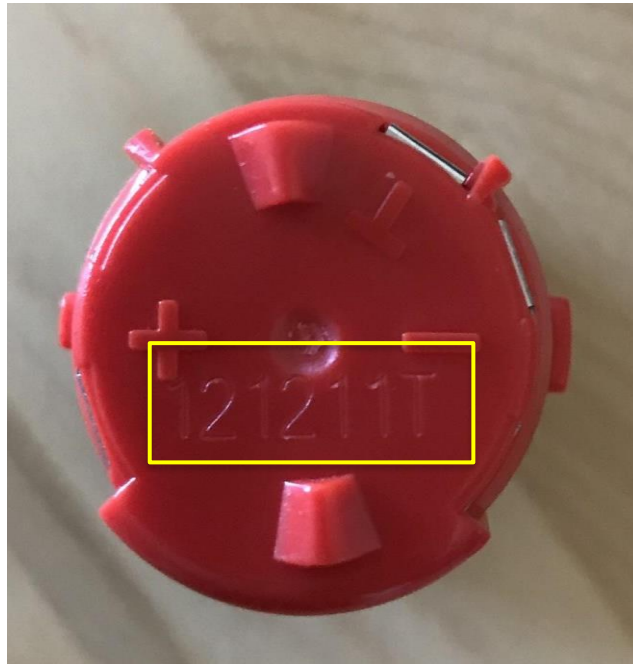
Date Code Check - M4

This translates to: 12/11/2012

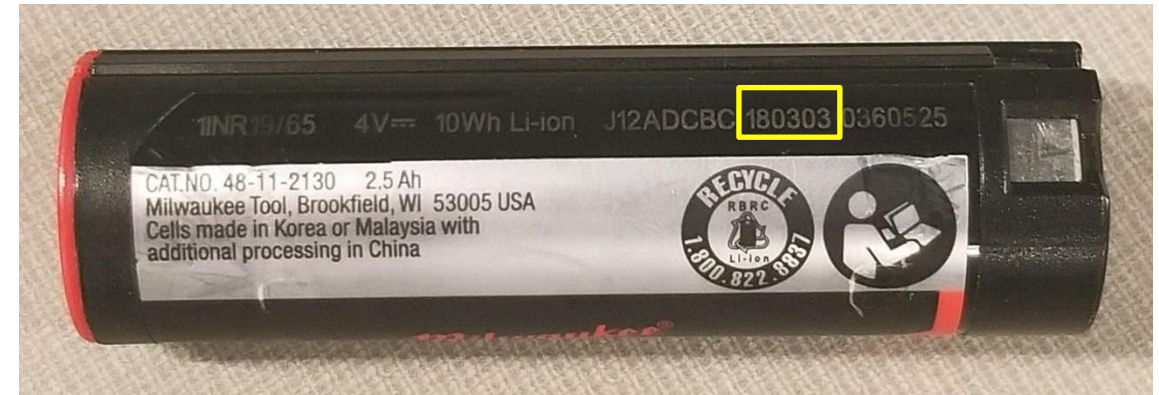
Date Code Check - RLUSB

Date Code format: YYMMDD This Date Code
Reads: 180303 = 03/03/2018

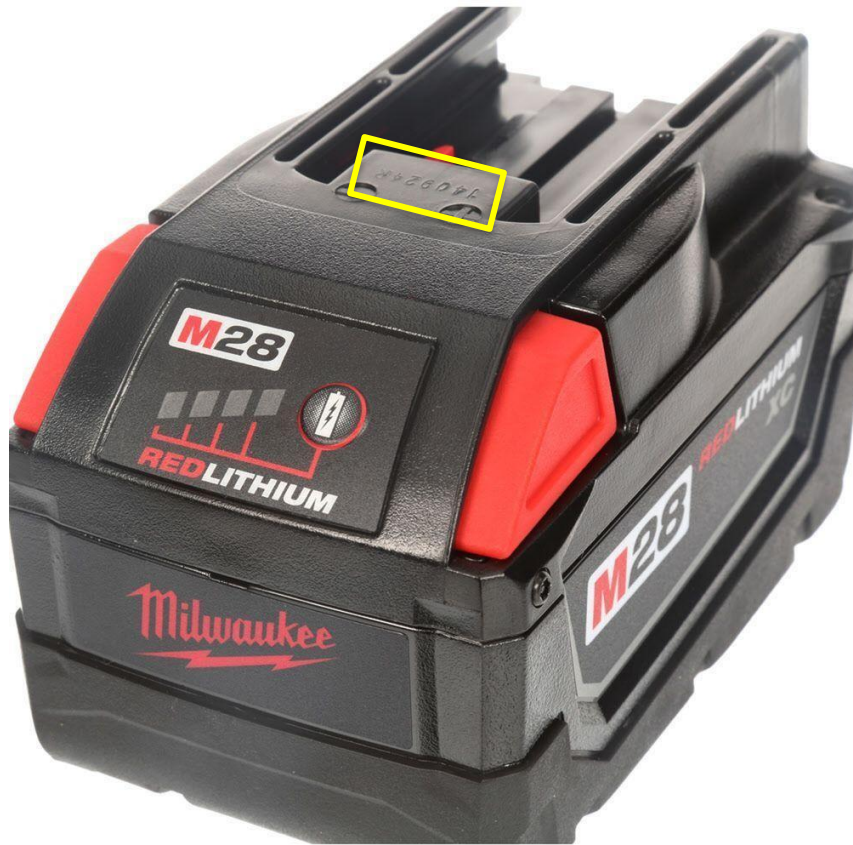
Date Code Check – M28

Date Code Format: YYMMDD = Cell Identifier

Date Code Reads: 140924R This translates to:

09/24/2014

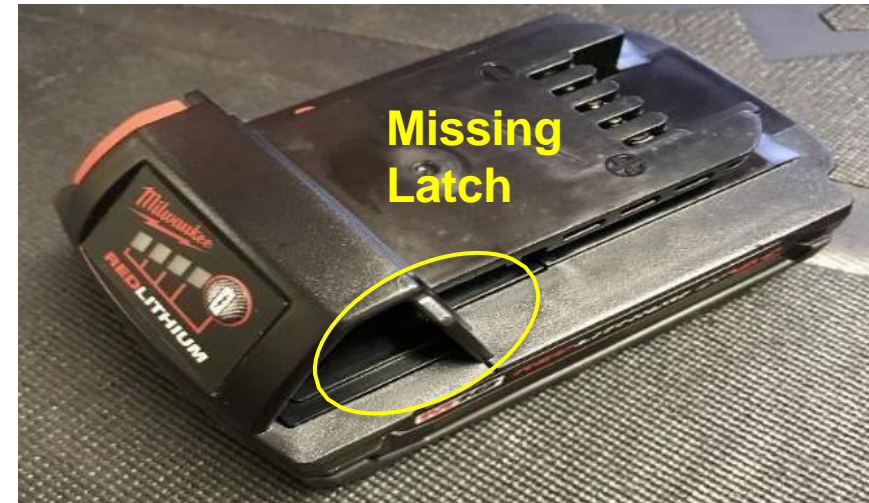
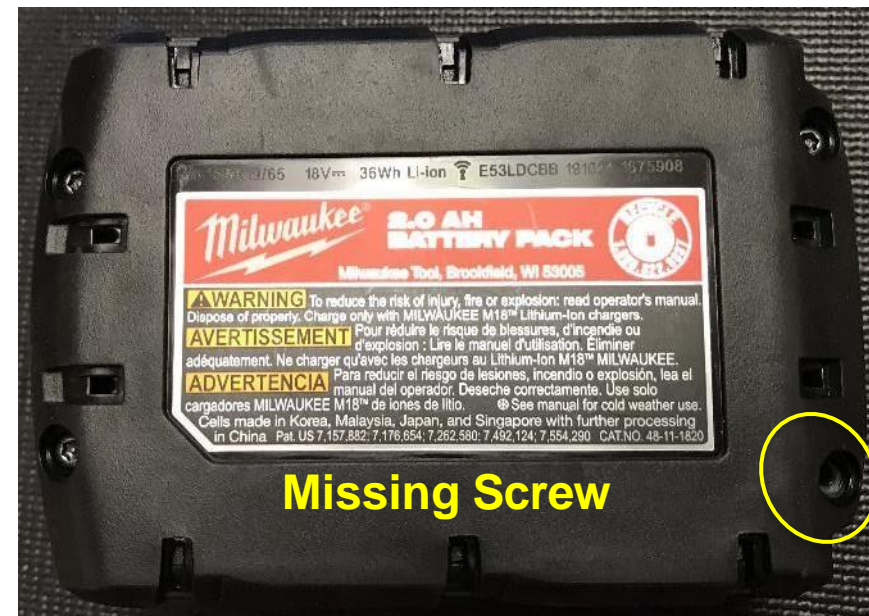
Missing Fasteners / Components

The battery is missing a screw or component (such as the red latch) but not from damage. (Out of box failure)

Warrantable

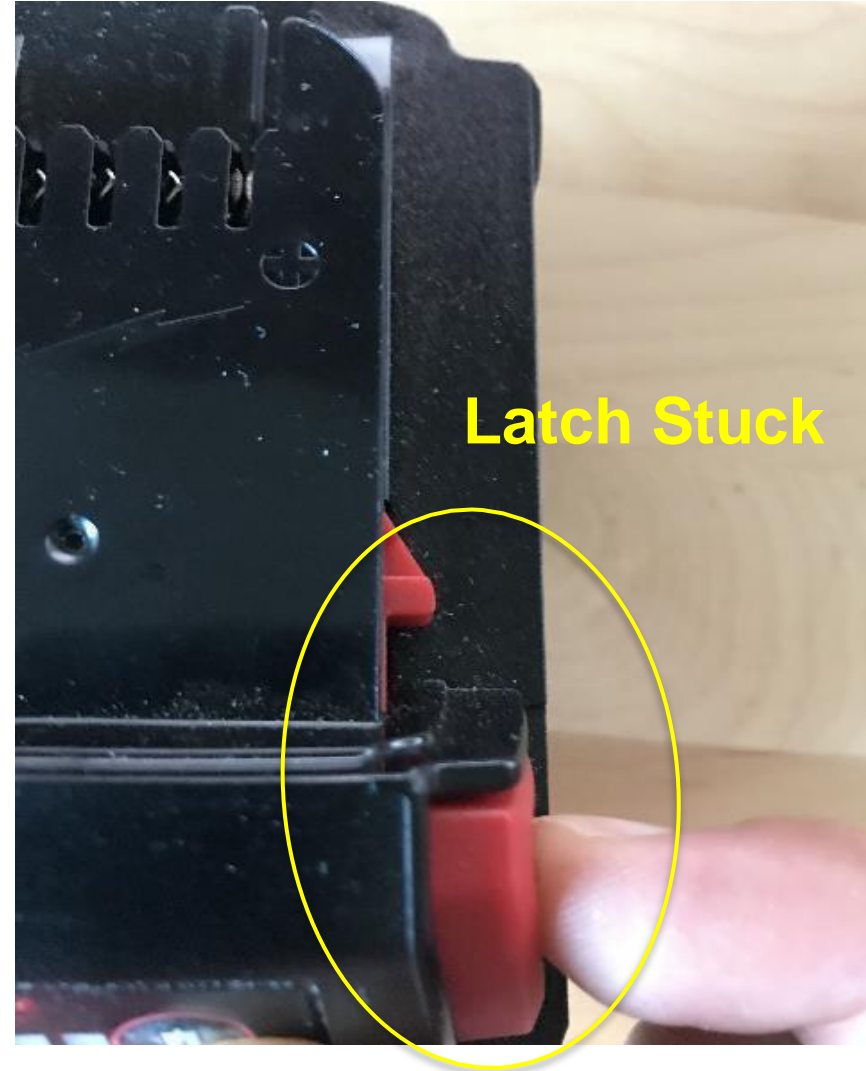
Latches | Slides | Guides | Handles | Locks Non-Functional

The battery latches fail to secure pack to tool / The red latch fails to depress.

Warrantable

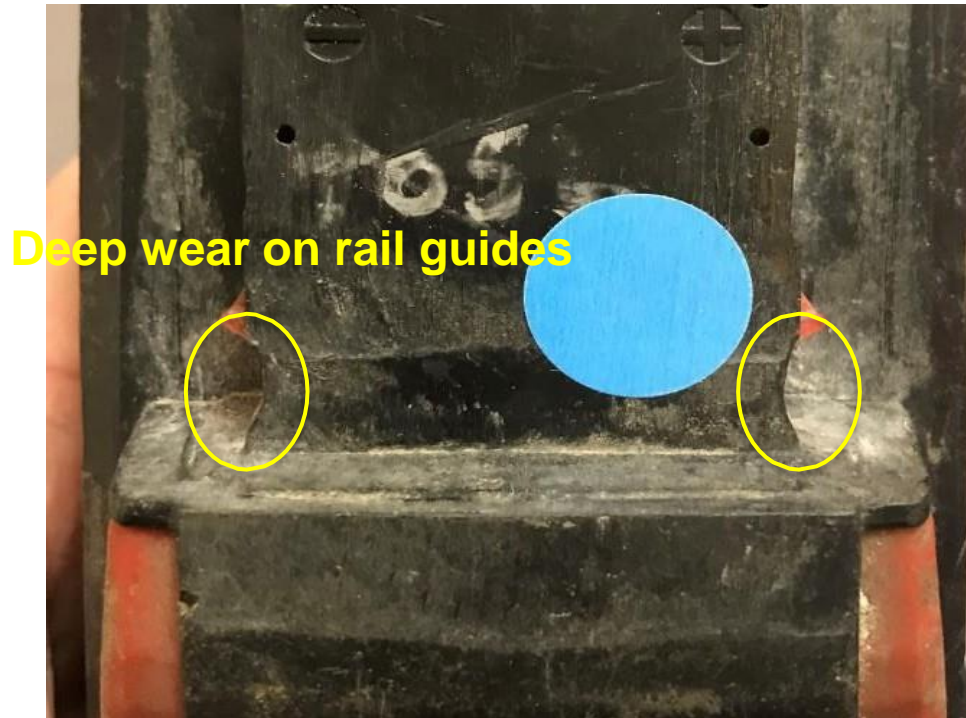
Battery Interface issue, excessive wear caused by tool side wear-out and high vibration

Warrantable

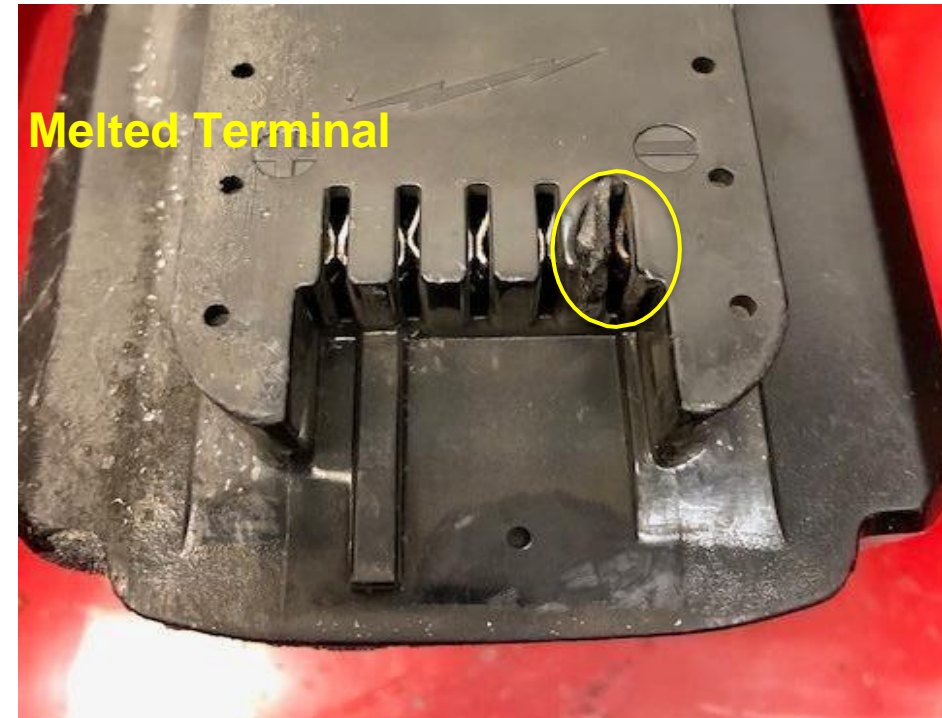
Battery Interface issue, Melted Terminal

- IF possible, Capture info about tool used on
- IF repeated claims from same end-user claim needs manager review

Warrantable

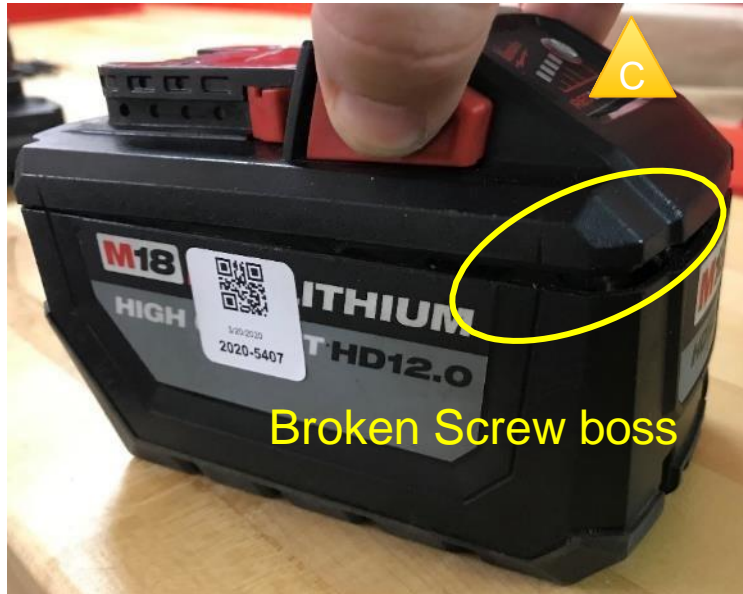
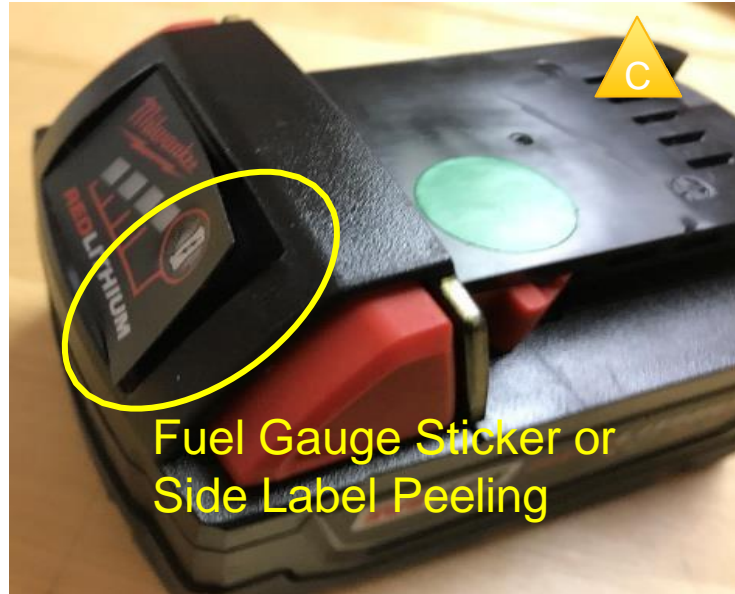
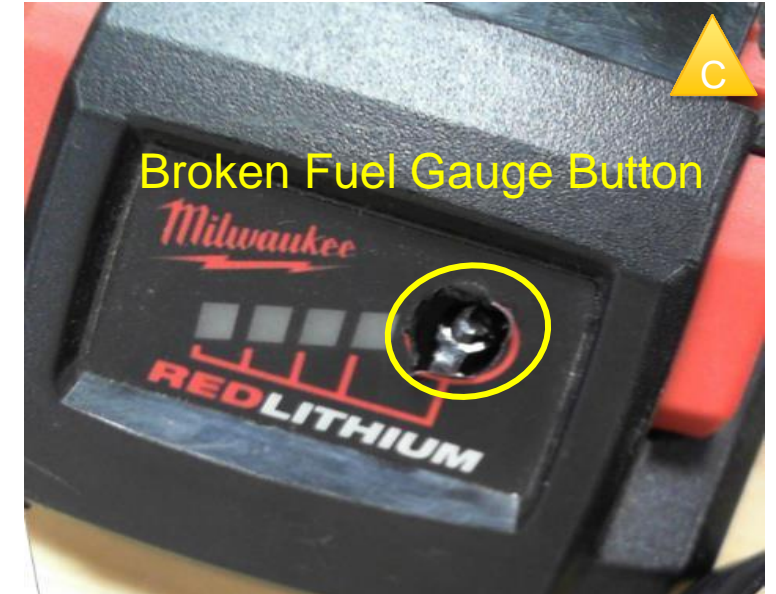
M18 Plastic Housing Damage / Cracking - Minor

Examples of Housing Damage – Minor

- For coded as Minor, the overall pack condition is good with just Key damage that could inhibit user experience
- Packs should continue evaluation steps to confirm this minor damage is not primary concern.
- Cases with top housing separation from the bottom housing would also be considered minor.
- More extreme than this is considered Major

Warrantable

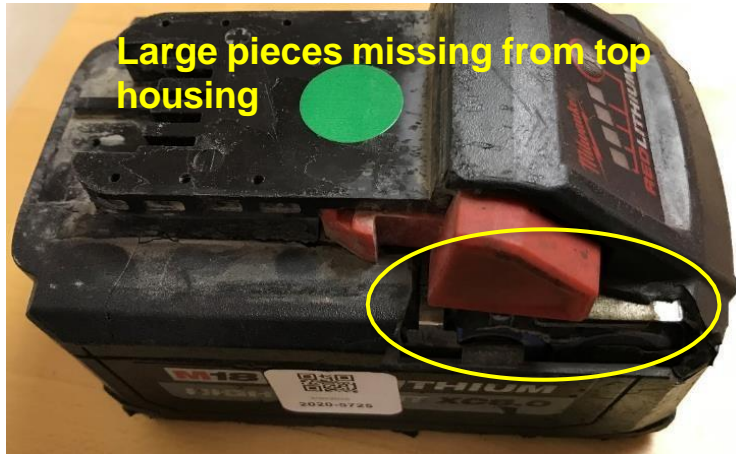
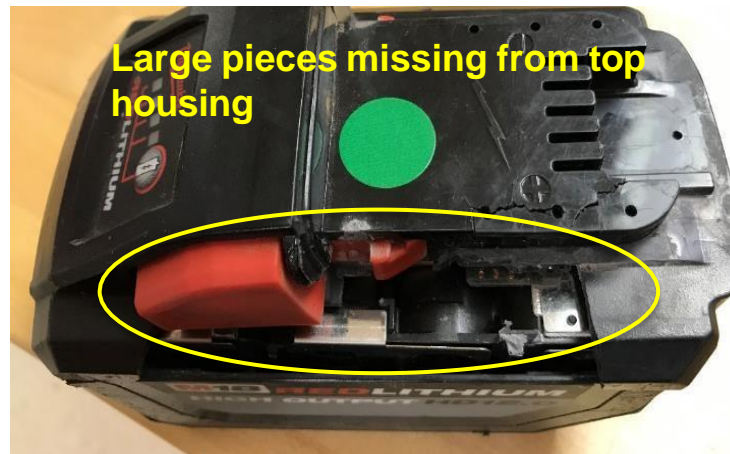
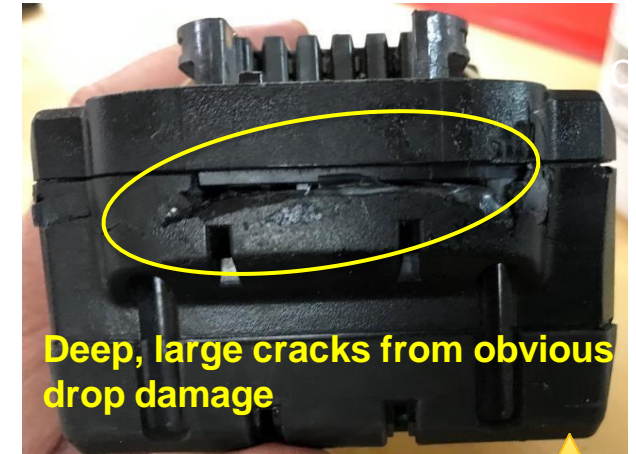
Plastic Housing Damage / Cracking – Major

Examples of what is considered housing damage - Major

- Large Cracks, Large Pieces Missing, Chemical Exposure, External Heat

Denied Warranty

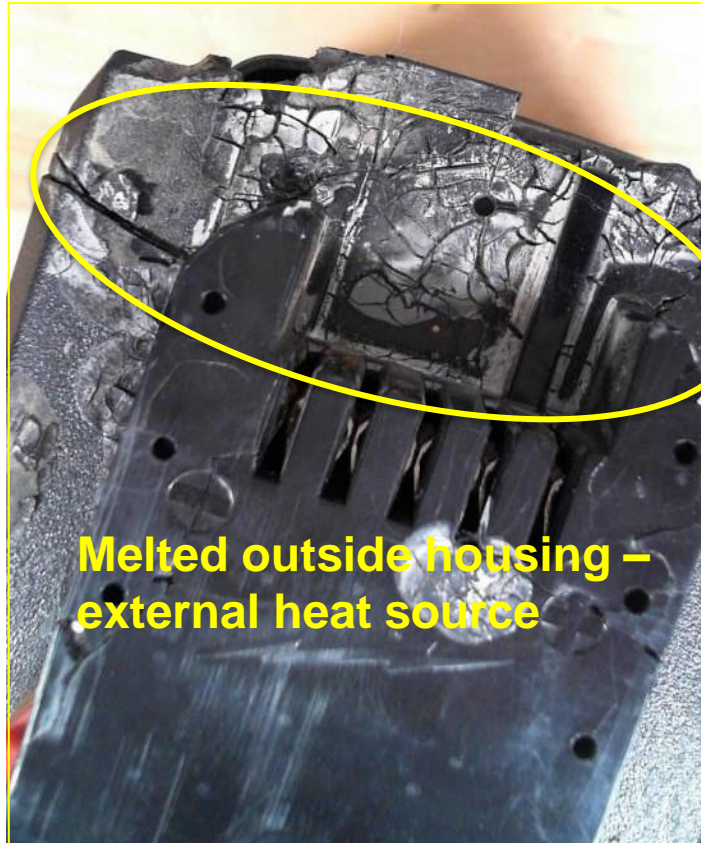
External Heat source Damage,
with only superficial plastic melting

Denied Warranty

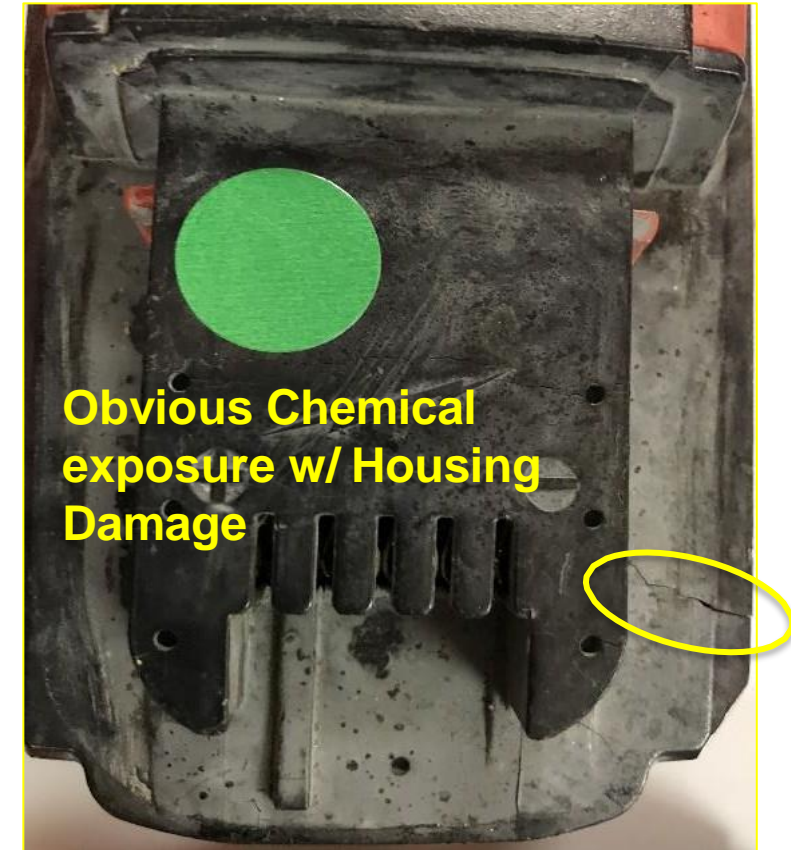
Chemical exposure seen by
“Graying” of plastic housing
(Usually acetone base cleaners)
Crack caused weaken plastic

Denied Warranty

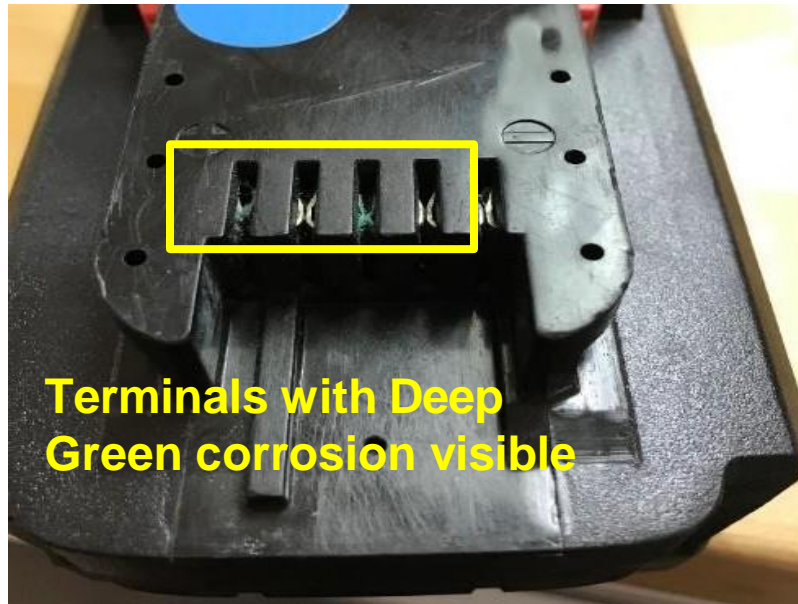
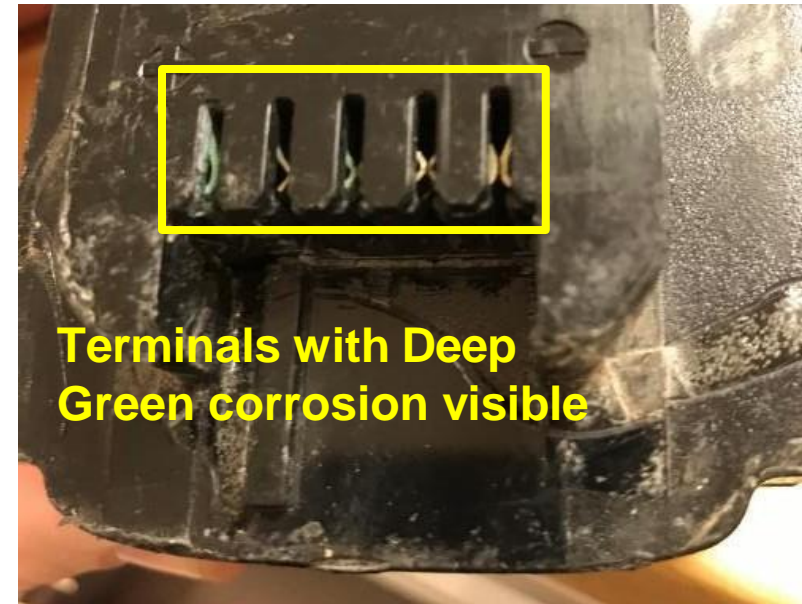
The pack shows heavy signs of environmental exposure.

Heavy Corrosion on the terminals means there is a high likelihood of corrosion on the cell straps and PCBA

Denied Warranty

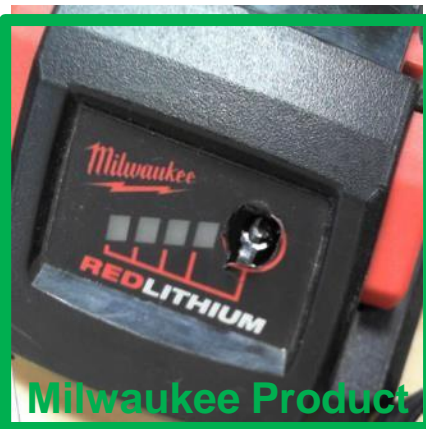
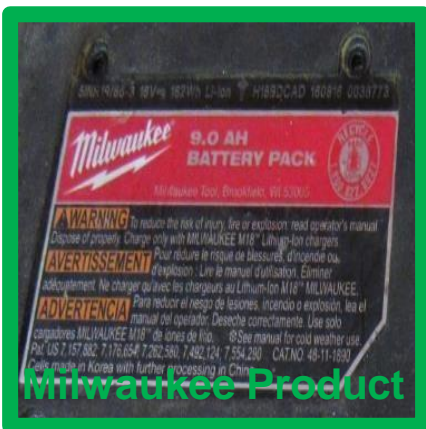
Milwaukee Product

Examples of Counterfeit Product / Fraud
Denied Repair

- “RED” is shade of orange on counterfeit
- Plastic Bottom on counterfeit instead of rubber over mold
- Differences in plastic shaping
- Missing tamper proof screws

Denied Repair

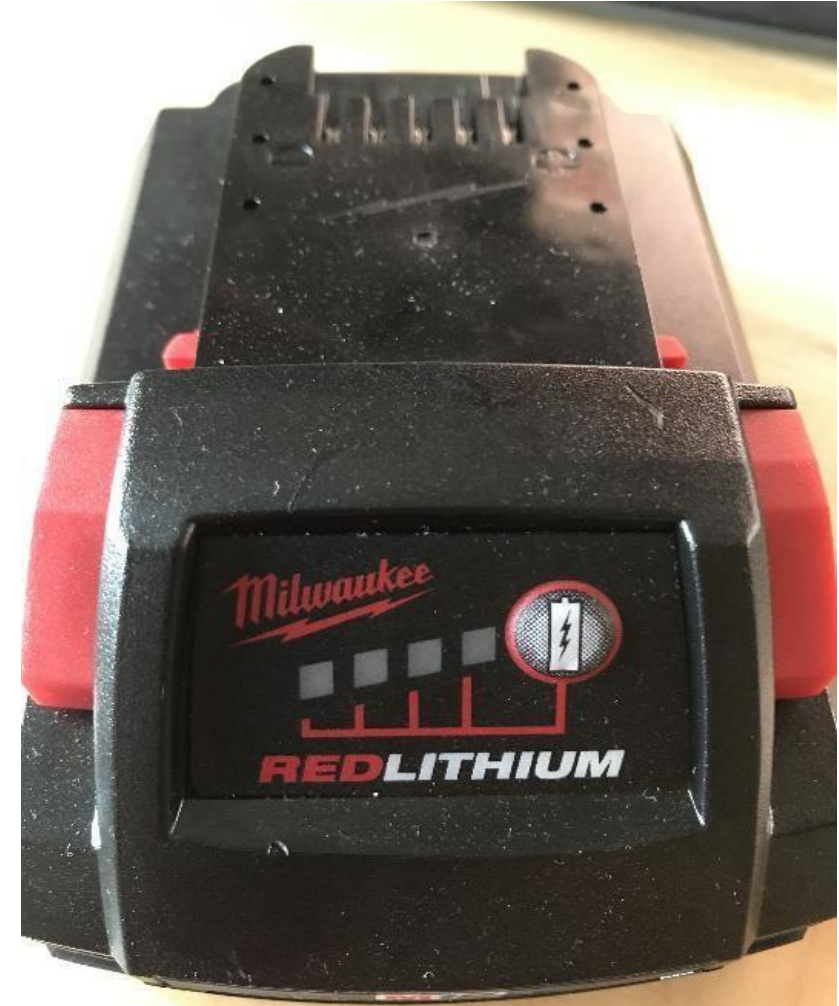
Over Discharged (Dead / Will Not Charge)

M18:
No lights illuminate on Fuel Gauge / Pack voltage less than 5V.

M12:
Pack Voltage less than 3V.

MX FUEL:
No lights illuminate on Fuel Gauge

Warrantable

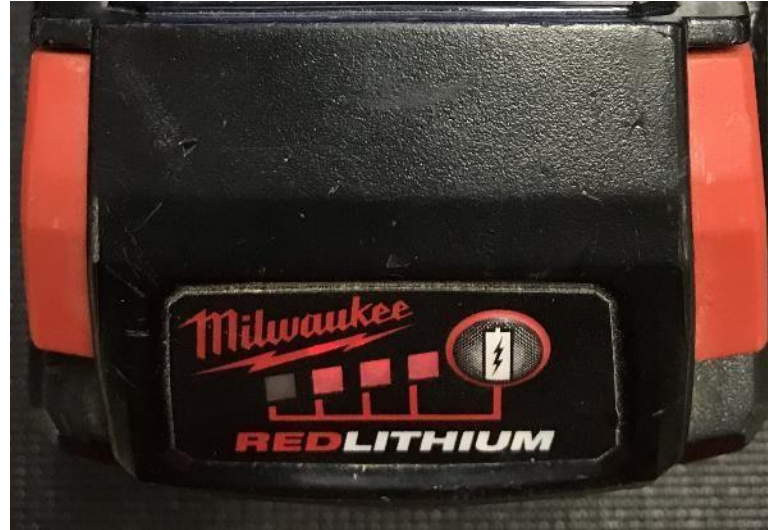
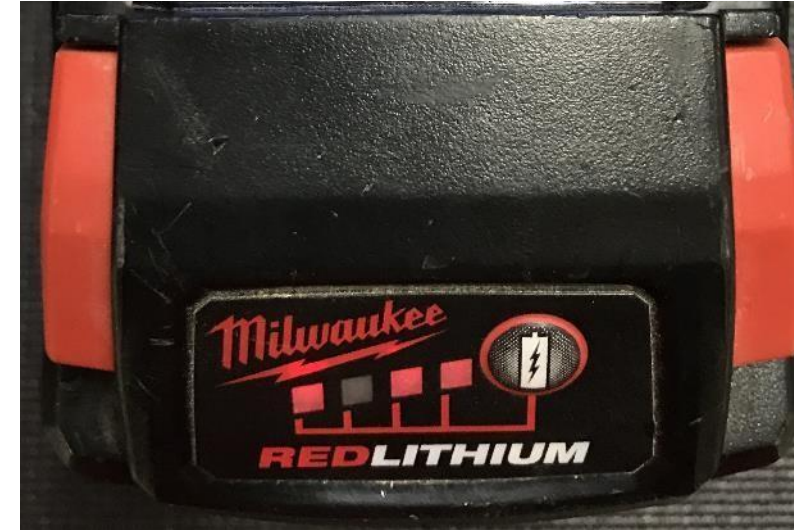
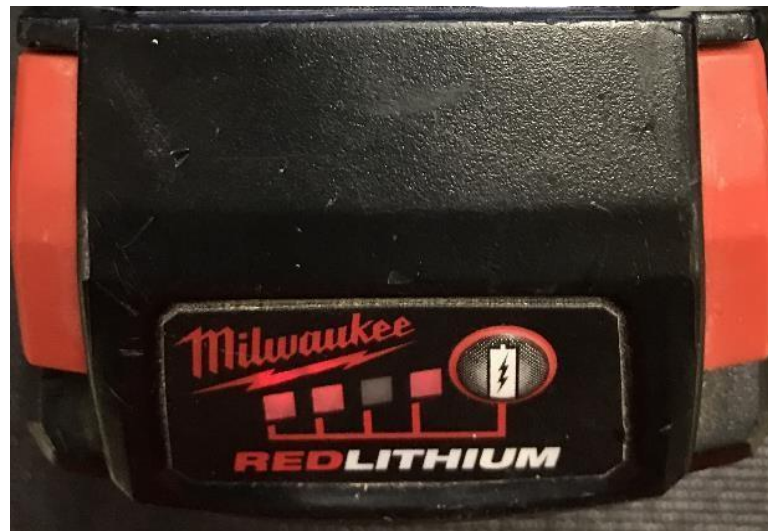
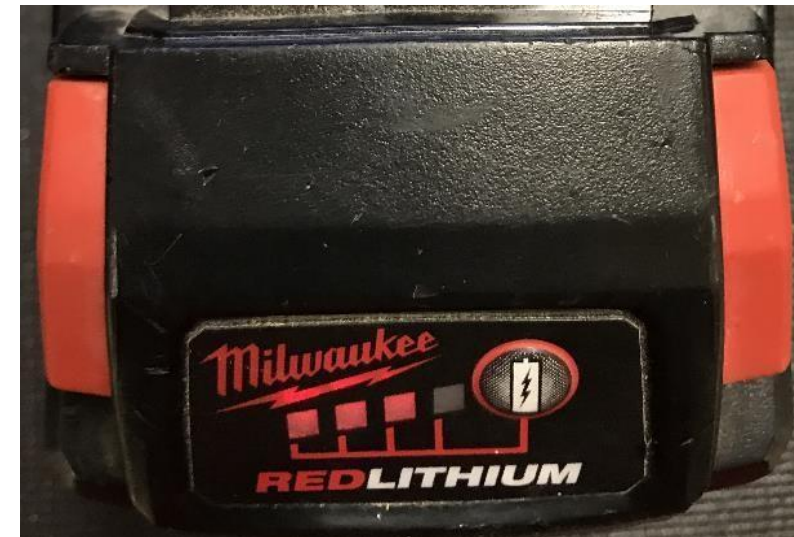
Fuel Gauge Non-Functional

With the battery fully charged, Fuel Gauge LED(s) fail to illuminate. (Pack must not have cell imbalance)

Warrantable
